A&P/Waldbaum's Supermarket: Capstone 60 with Desiccant Unit

DOE/CETC Workshop on
Microturbine Applications
January 21, 2004

Hugh I Henderson, Jr., P.E.
CDH Energy Corp.
Cazenovia, NY
www.cdhenergy.com

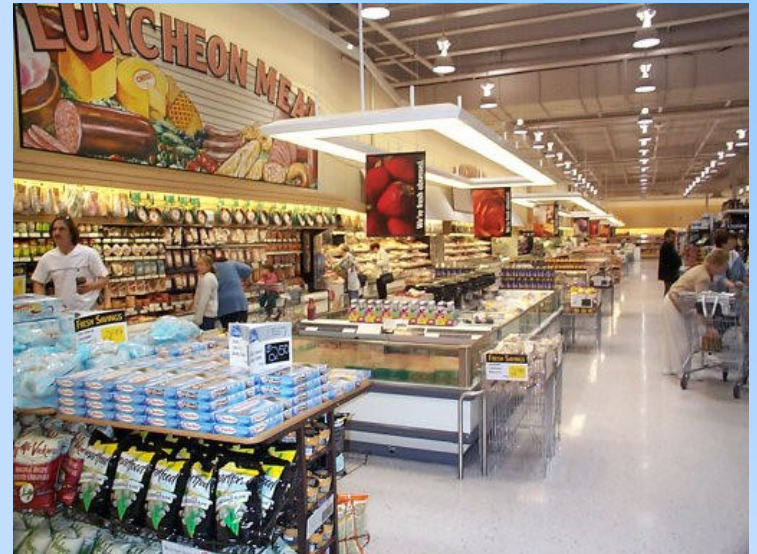
CHP in Supermarkets

- Peak is 400-600 kW for typical store
- Significant space heating loads due to refrigerated display cases
- Desiccant dehumidification is widely used in supermarkets
 - more than 1,000 desiccant units in US stores
- Good balance between thermal and electrical loads

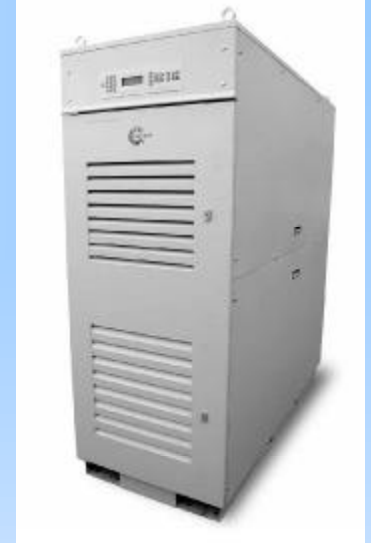
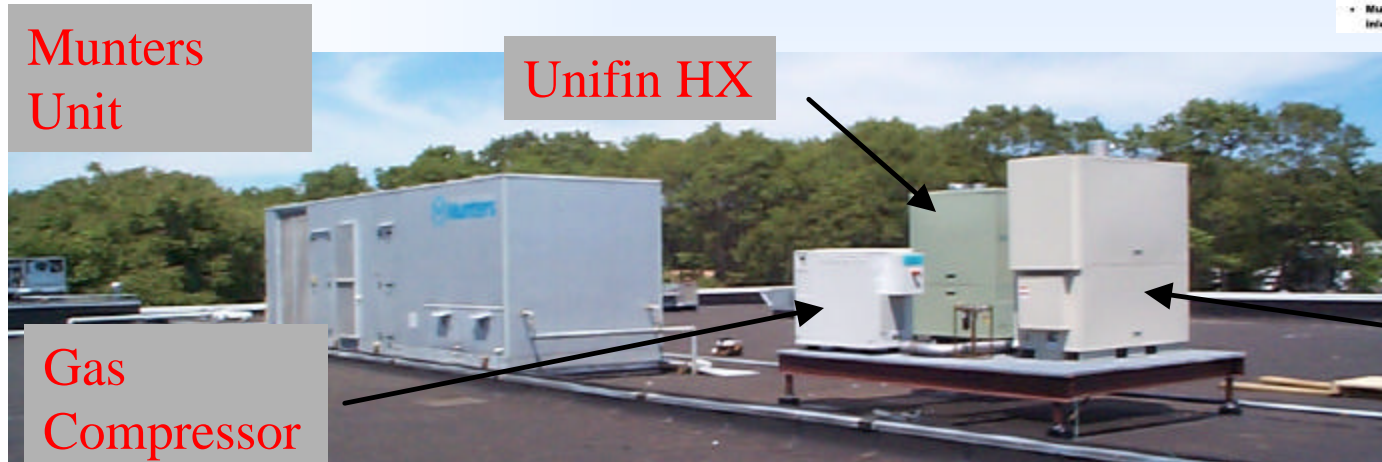
- Capstone 60 kW Microturbine
- Nat. Gas Compressor (scroll)
- Unifin Heat Exchanger
- Hot Water Coils Installed in Munters Unit

Munters Unit

Unifin HX

Gas Compressor

Capstone C60

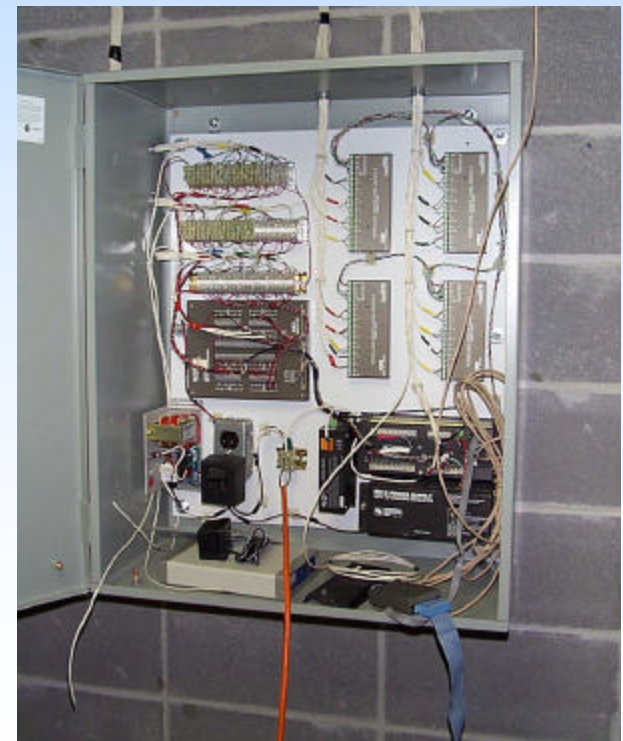
- Installed data logging equipment to quantify thermal and electric performance
 - electrical turbine output (kW, amps, volts)
 - thermal output of Unifin HX (flow, ΔT)
 - turbine exhaust (T, static P, flow)
 - desiccant/HVAC unit performance (T, RH, kW)
